# Manhole Inspection Summary

Manhole # S19GG2017MH

**Location** Address: **1330 SMITH AVE**

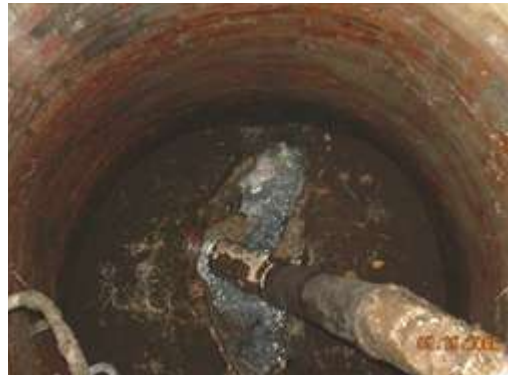
Top View

Evidence of surcharge - Bench debris.  
Channel debris.

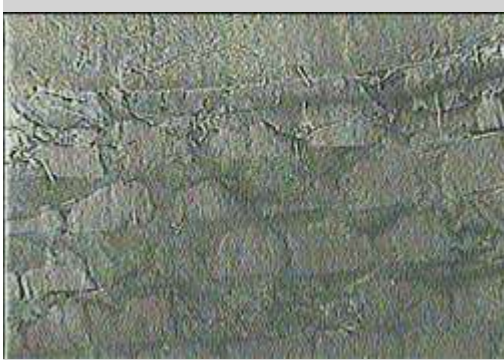
Defect

Frame leaks. Adjustment deterioration,  
loose brick and infiltration. Corbel  
infiltration.

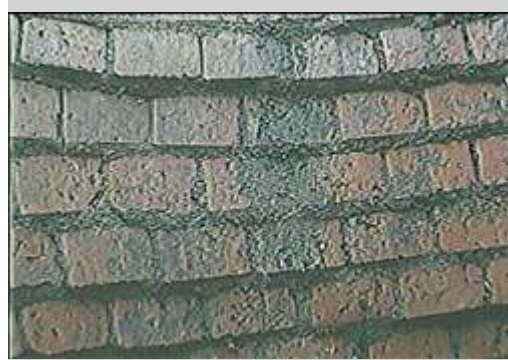
Defect

Adjustment deterioration and infiltration.

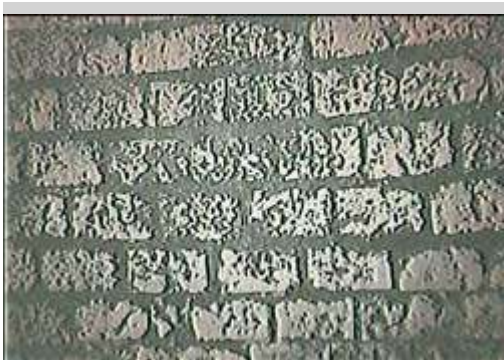
Defect

Barrel infiltration.

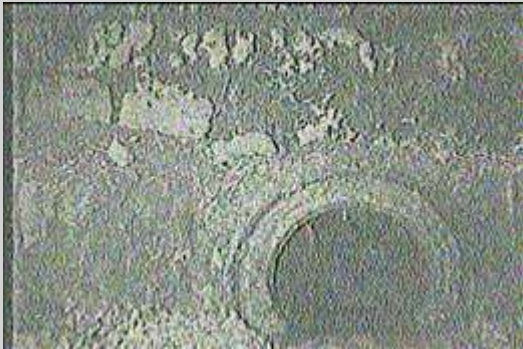
### 8 in. Circular Gravity Sewer Pipe Out @ 12 O'Clock

Comments **The O12 pipe seal is not flush to the pipe.**

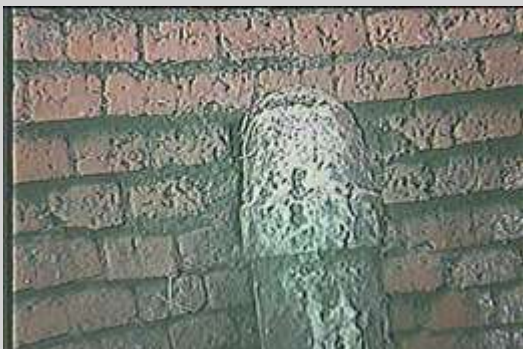
### 6 in. Circular Gravity Sewer Pipe In @ 4 O'Clock

Infiltration: **Evidence** Pipe Seal Cond: **Broken**

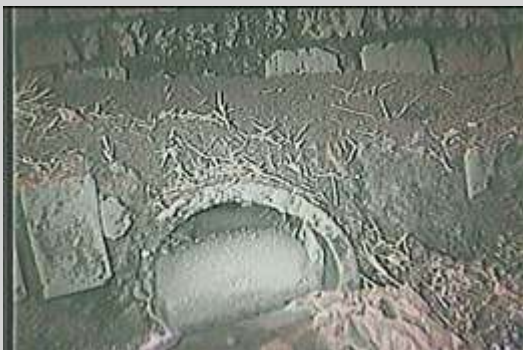
### 8 in. Circular Gravity Sewer

Bench and Channel root intrusion.

Deposits: ☐ None ☒ **Mud** ☐ Sludge ☒ **Debris** ☐ Grease

Pipe Seal Cond: **Roots**
